DAMAGE AND INTENSITIES IN THE MAGNITUDE 7.8 1931 HAWKE'S BAY, NEW ZEALAND, EARTHQUAKE

David J. Dowrick¹

SUMMARY

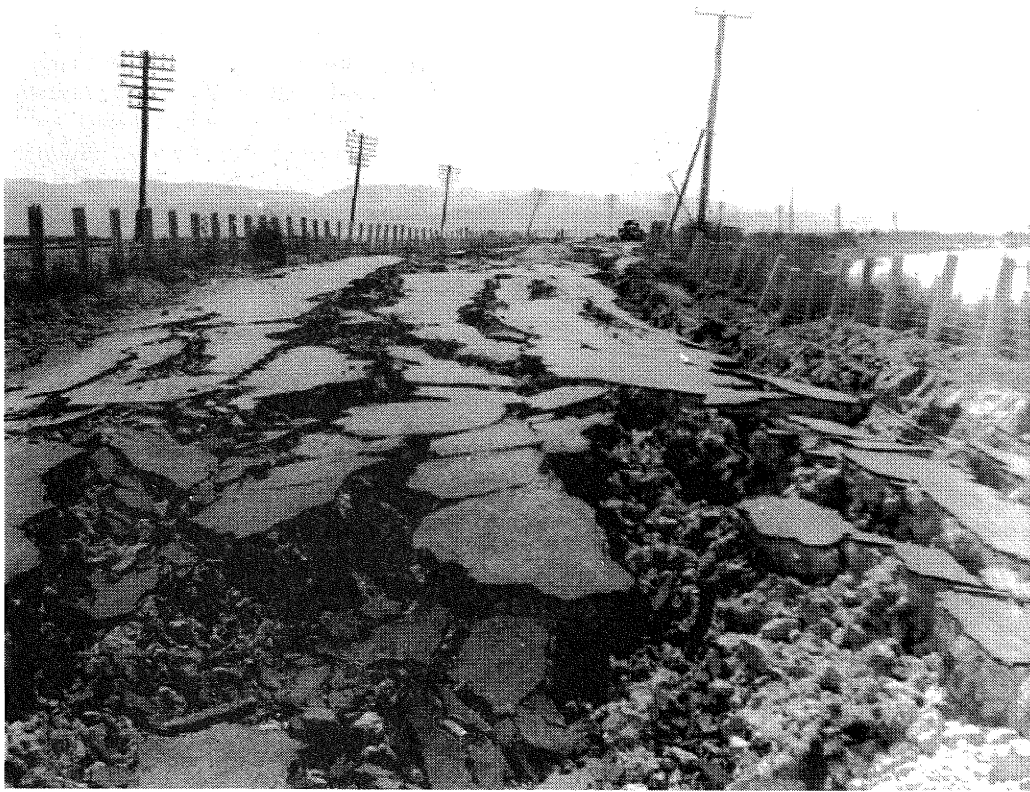
The damage to the roads and railways was dramatic on the man-made embankments across the harbour in the near-fault zone around Napier, as seen in Figure 4 and other contemporary photographs, e.g. References 22-24. According to Callaghan [12] the Napier-Wairoa road was blocked in many places by slips in road cuttings, while the Napier-Taupo road was much less affected, being open again within two or three days. In addition, embankment approaches to bridges subsided badly and spread laterally in many instances. The main road

Figure 4: *Photograph showing severe lateral spreading of embankment of road across Napier Harbour. (Courtesy of the Alexander Turnbull Library, Tyndall Collection, Wellington).*

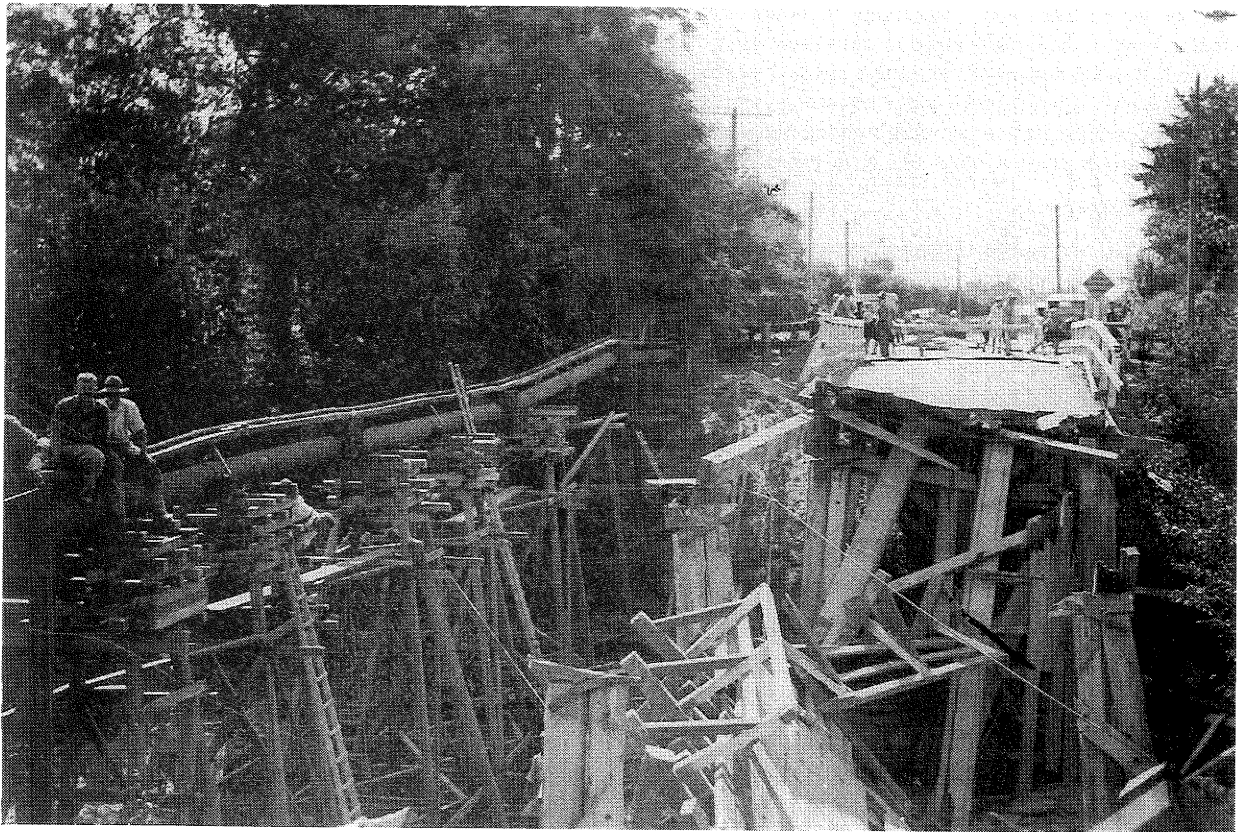
In Hastings the water mains sustained very little damage apart from subsidence at bridges and fillings. A section of the main supply pipe to Hastings supported by the Havelock North bridge was lost when that structure collapsed (Figure 5). Water supply was apparently generally restored within a day or two [Ref. 22, p. 112]. Artesian water from Hastings was temporarily pumped to the Havelock Hills reservoir to give more head. Hastings water supply was maintained by pumping artesian water directly into the mains. The pipe bridge was reinstated on the 10th of February, seven days after the main shock. The mains pressure was quite satisfactory at 100 lb/sq.in. [690 kPa] by 9th February.

Figure 5: *Photograph showing destruction of Hastings-Havelock North road bridge and temporary restoration of water main. (Courtesy of the Alexander Turnbull Library, P.A. Ashcroft Collection, Wellington).*

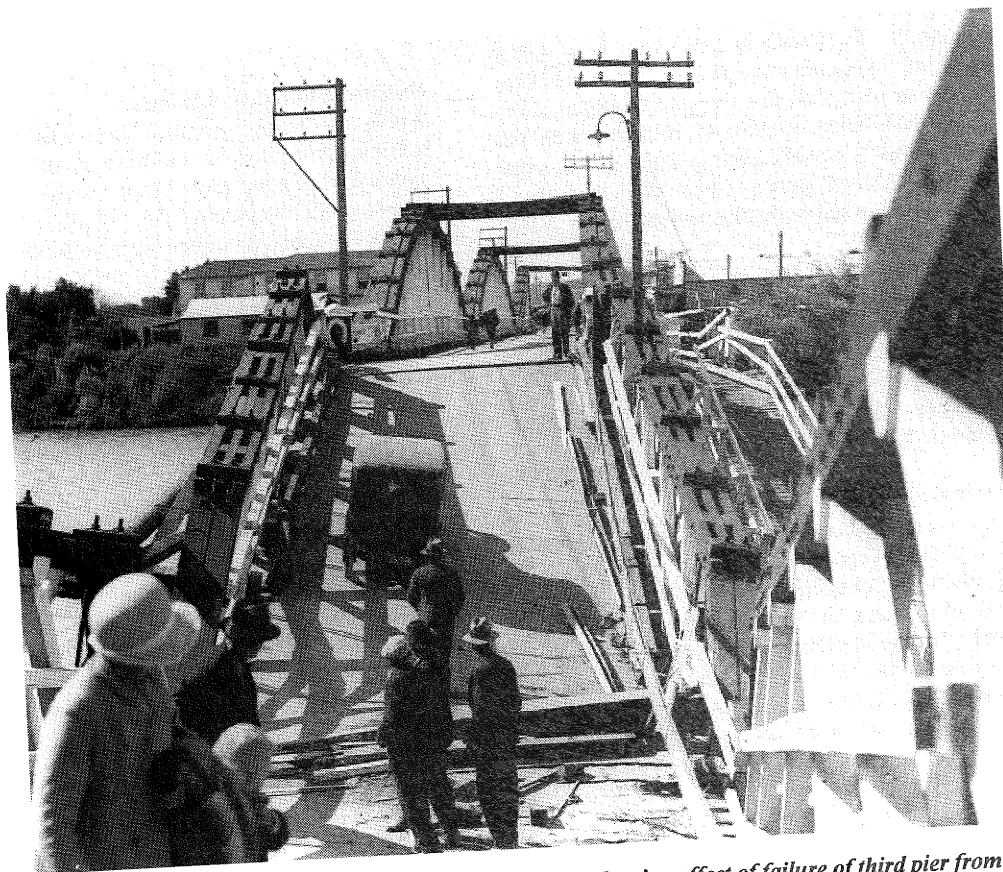
Damage to some of the road and rail bridge structures has been described in contemporary terms by Furkert [9], who discussed the nature of the damage to a number of road and railway bridges. Photographs of the notable incidents appear in various publications [22-24], including the Havelock North - Hastings road bridge (Figure 5). Another example is the Wairoa road bridge (Figure 6) which lost two adjacent 60 foot (18.3 m) spans at the southern end. According to Smith [25], the northern bank of the river slumped towards deep water, "with the result that the bottom of the nearest pier was pushed out from the bank". From Figure 6 and other photographs the pier that displaced the most was the third from the north, and as it was fully in the river it may also have been affected by liquefaction.

Figure 6: *View southwards of main road bridge at Wairoa, showing effect of failure of third pier from north abutment. (Courtesy of New Zealand Herald.)*

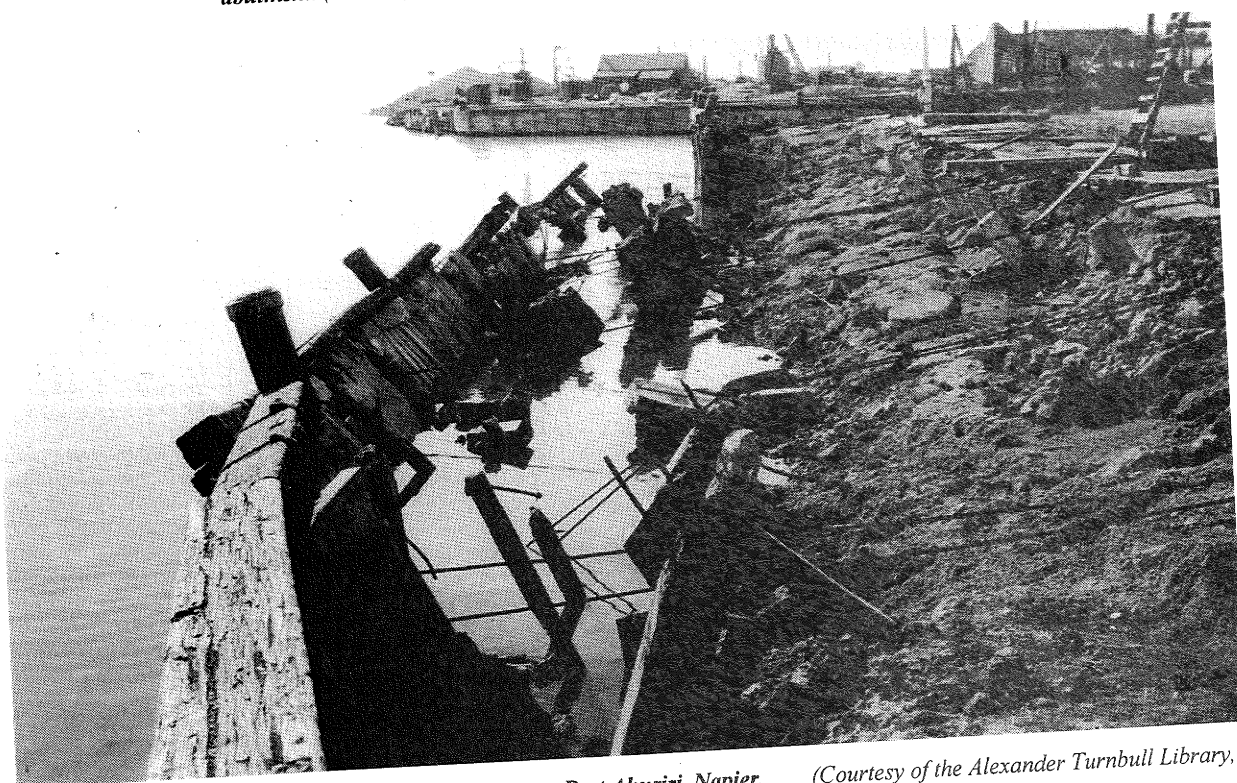
Ground shaking and liquefaction apparently combined to cause severe damage to wharves at Napier as seen in various photographs [22,23], an example of which is given here (Figure 7). In the *Remark Book* of H.M.S. "Veronica" (which helped in search and rescue operations), the damage was summarised thus:

- (1) All wharves in the Inner Harbour (Figures 3 and 7) are severely damaged and are at present unserviceable.
- (2) The breakwater is only slightly damaged.
- (3) Breakwater wharf is damaged beyond repair.
- (4) Glasgow wharf has suffered considerable damage, but is not beyond repair.

the piles. Practically no damage was done to the deck or bracing." In the above quotation Furkert was evidently referring to Glasgow wharf which was a finger wharf coming off the breakwater, an entirely concrete structure without rock or hydraulic fill. As might be expected, some of the worst damage was experienced by the wharf structures built parallel to and supporting land areas which were generally reclamations, e.g. as shown in Figure 7.

Figure 7: *View northwards along failed West Quay at Port Ahuriri, Napier. (Courtesy of the Alexander Turnbull Library, D.H. Jones Collection, Wellington).*

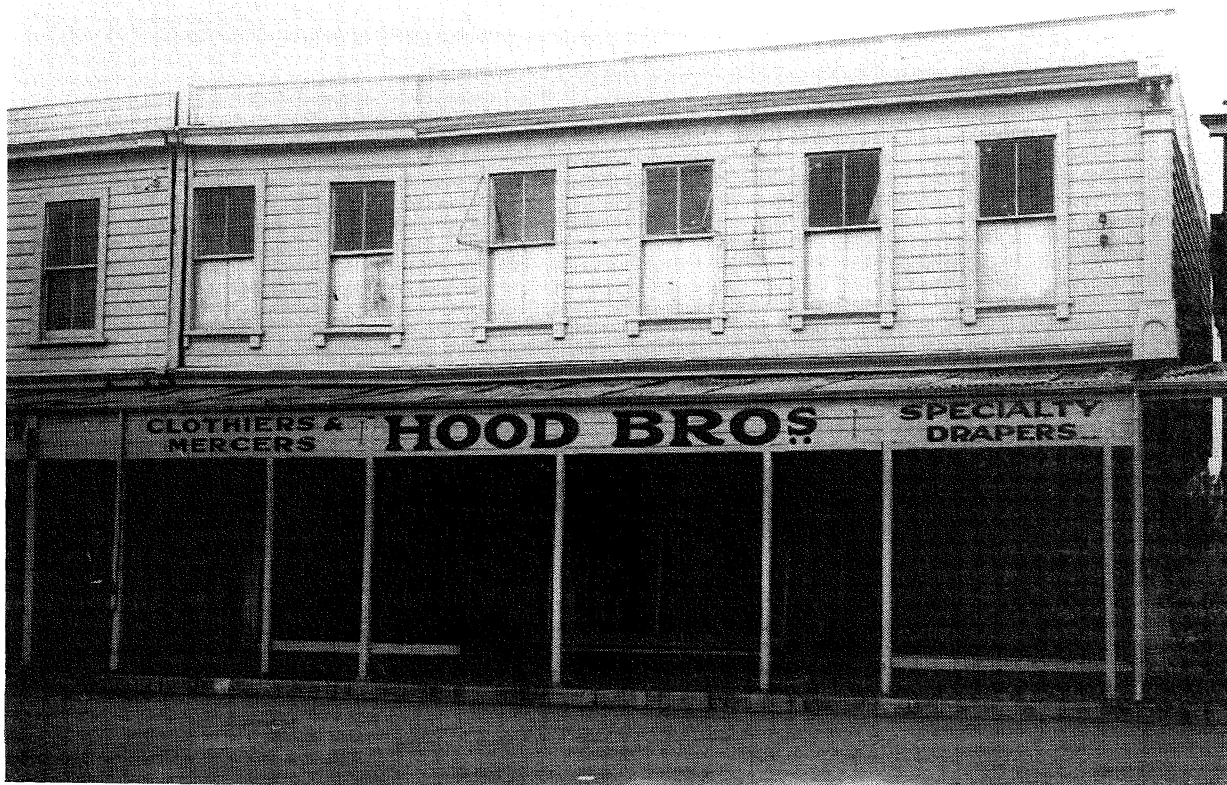
Figure 8: Example of racking destroying plate glass windows in the weak front wall of shops built of timber. Hood Brothers, Waipawa, in the MM8 zone. (Courtesy of the Alexander Turnbull Library, Insurance Council of New Zealand Collection, Wellington).

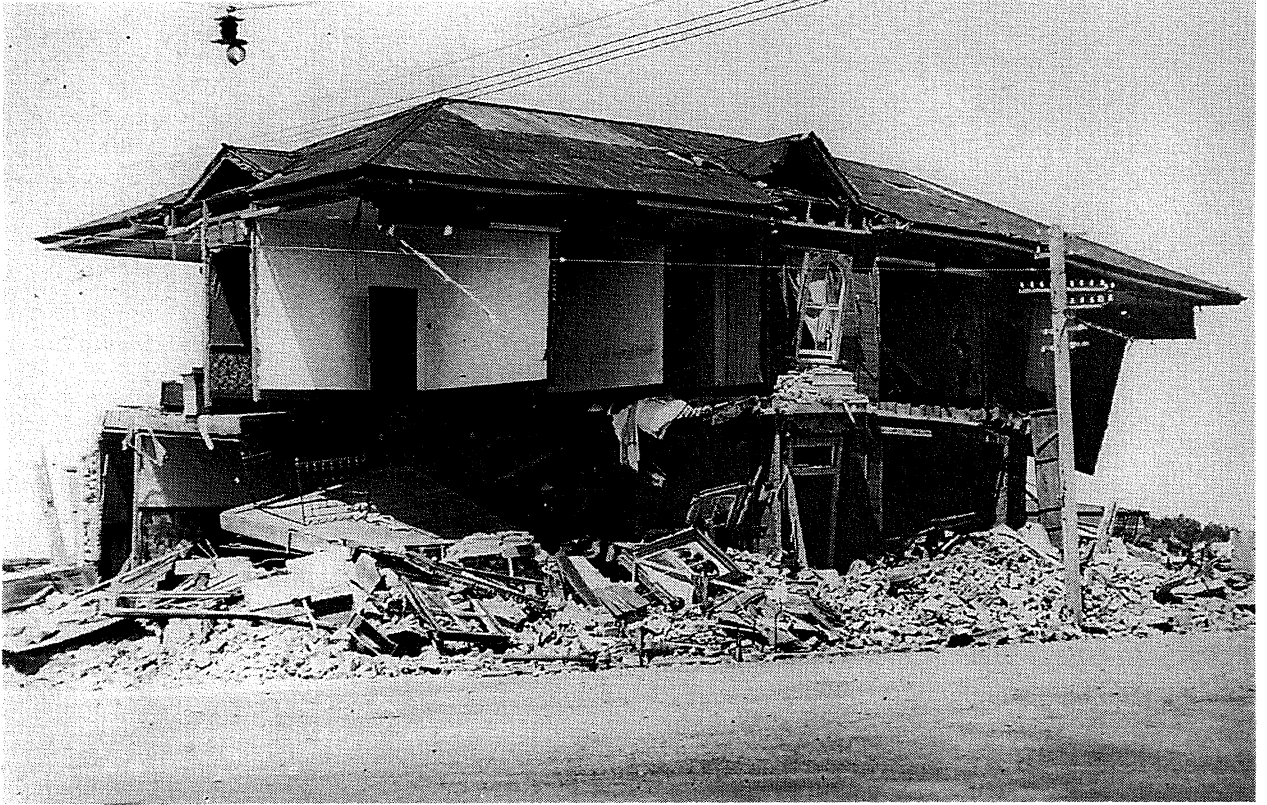
Figure 9: (a) A poor brick building. The Taradale Hotel illustrating two weaknesses in brick construction: (i) external brick walls not fixed to partitions; (ii) weak mortar (cleanly separated bricks). (Courtesy of the Alexander Turnbull Library, Insurance Council of NZ Collection, Wellington).

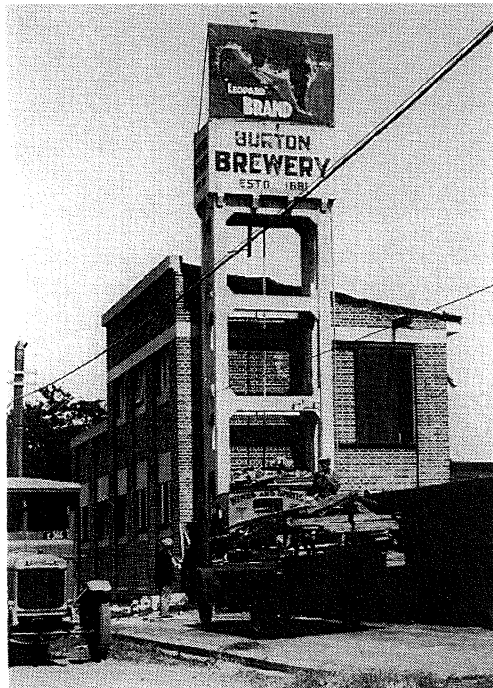
As noted earlier some brick buildings in the Hastings/Napier area suffered little damage. An example is the two-storeyed Burton Brewery in Hastings, as illustrated in Figure 9(b), which evidently was protected by the presence of reinforced concrete ring beams. It lost an unbraced brick parapet, but otherwise suffered only minor cracks.

Figure 9: (b) A successful brick building. The Burton Brewery, Hastings. (Courtesy of the Alexander Turnbull Library, Insurance Council of NZ Collection, Wellington).

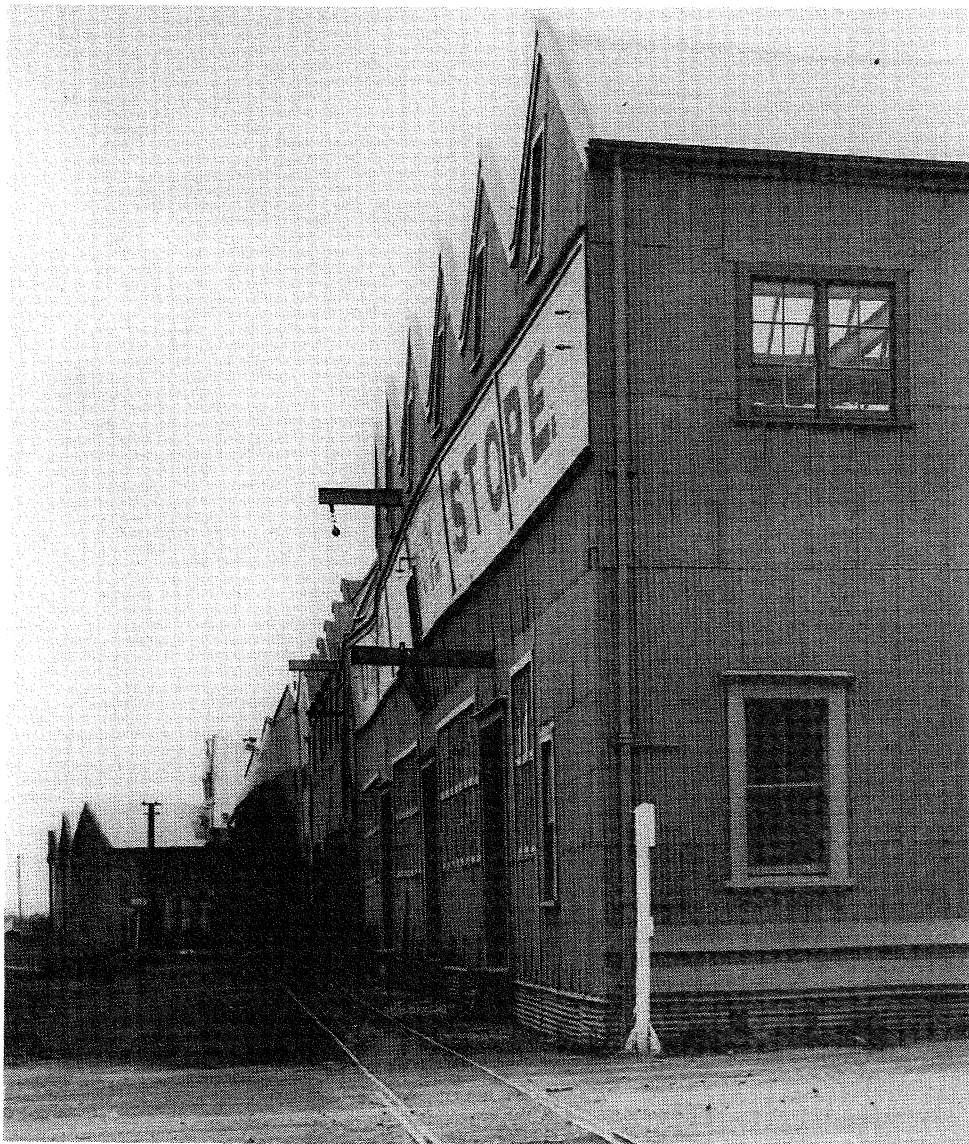
Figure 10: Dalgety's No. 2 Store, Port Ahuriri, Napier one of the few steel-framed buildings in the region, was inadequately braced. (Courtesy of the Alexander Turnbull Library, Insurance Council of NZ Collection, Wellington).

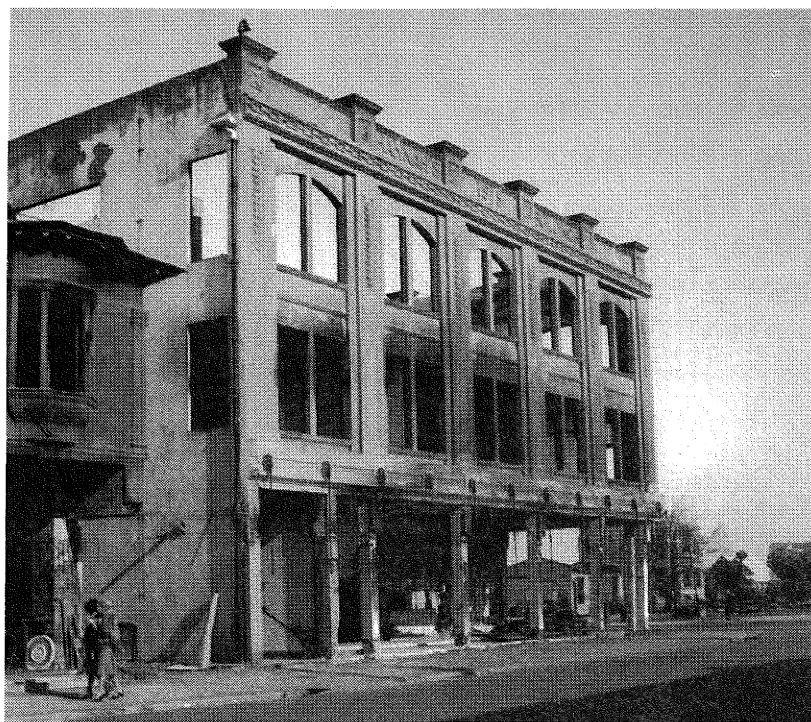
Figure 11: (a) A successful reinforced concrete building. Hannah's shoe shop, Napier, a "corner building", MRF + concrete block infill. (Courtesy of the Alexander Turnbull Library, Wellington).

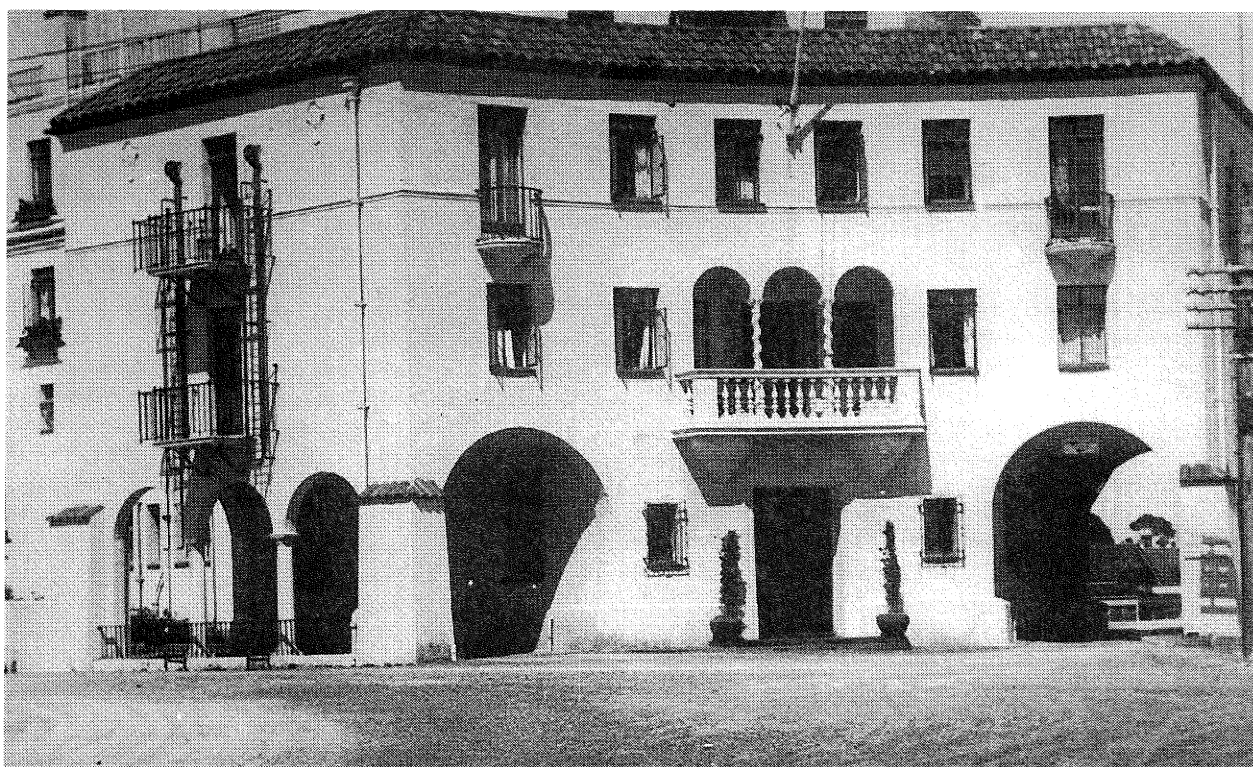
Figure 11: (b) A poor reinforced concrete building. The Nurses' Home at Napier Hospital before the earthquake, the only r.c. building to collapse completely, due to a bottom storey weakened by large openings and little reinforcement (Courtesy of the Alexander Turnbull Library, Wellington).
